## The Mary Rose

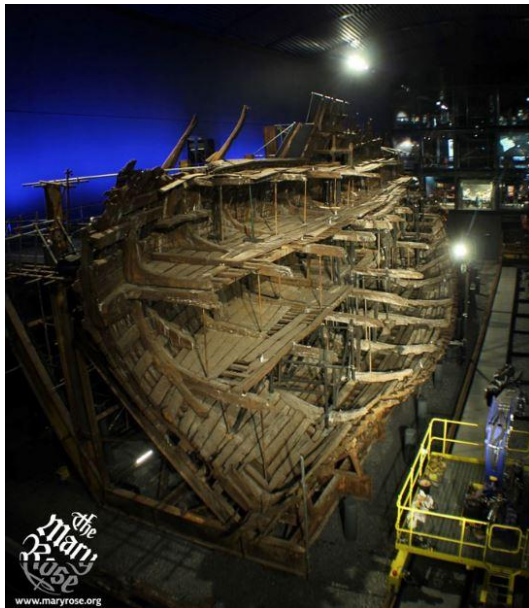
To preserve the structure above water they sprayed the hull with a 20% concentration of Polyethylene Glycol (PEG) solution for 19 years, freeze drying , followed by 3 years of air drying. After installing scaffolding supports they monitored the wood movement with overlaid imaging over the next 3 years and made the necessary adjustments. She has since (prior to Covid-19) been open to the public across from HMS Victory.
